Access Study to all Pertinent Parts of  
Dam Projects During High Reservoir  
Conditions

# Upper Connecticut Basin New Hampshire and Vermont

JULY 1992

US Army Corps  
of Engineers  
New England Division

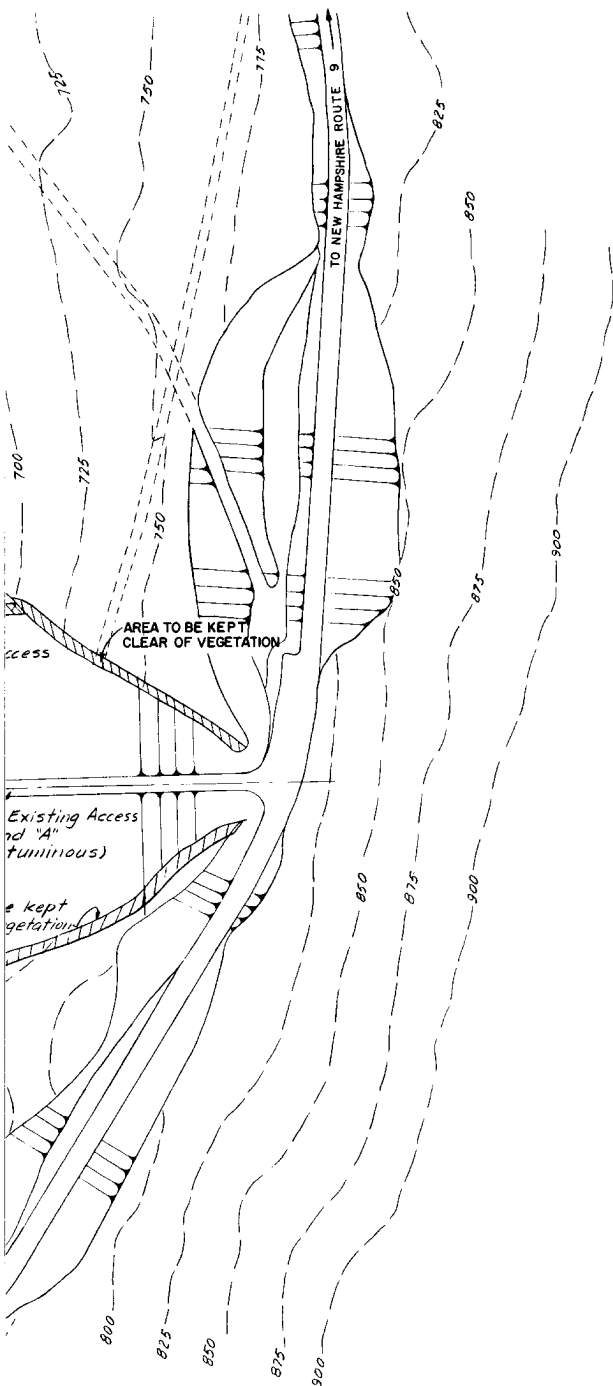
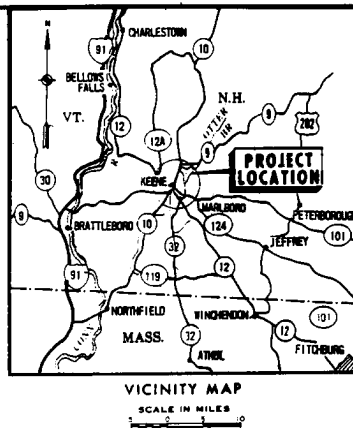
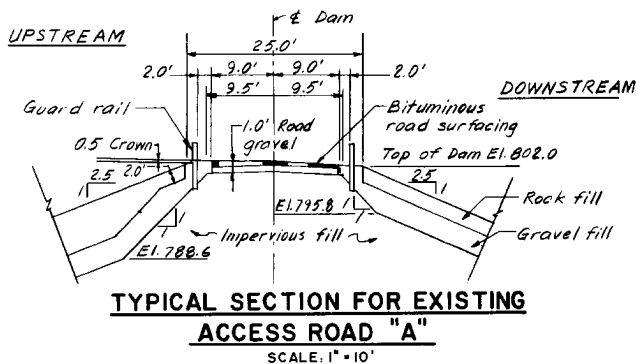
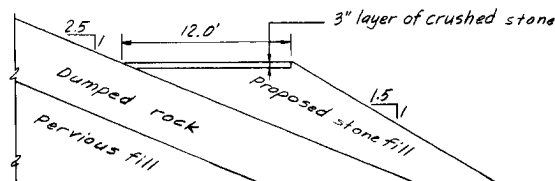
TYPICAL ROCK FILL SECTION FOR PROPOSED DAM ACCESS ROAD "E"  
SCALE: 1" = 5'

The recreational pool (elevation 701 feet NGVD) normally inundates the upstream toe of Otter Brook Dam. The west end of the toe area can be reached by descending from the rotary at the west end of the dam on Access Road "C". Access Road "C" is a 12-foot wide bituminous and gravel road. The bituminous concrete stops approximately 165 feet from the intake tower. It is in good condition but it has a steeper than 12.5 percent grade. However, there is no means, even if the pool was drawn down, to travel across the toe from the downstream end of Access Road "C".

7. Recommended Improvements. Access Road "E" should be constructed as shown on Plate G-1 to improve access to the upstream toe of Otter Brook Dam. It would be a rock fill road which would provide access at recreational pool level (elevation 701 feet NGVD) or lower. Vegetation should be removed periodically from the east upstream abutment.
